Causes of Drillhole Deviation during Exploratory Drilling for Gold: A Case Study from Geita Gold Mine-Star and Comet Deposit, Tanzania

Pili Ayoub, Sankaranna Gaduputi* and Godson Godfray

Department of Geology, College of Earth Science and Engineering, The University of Dodoma, P.O.Box 251, Dodoma, Tanzania

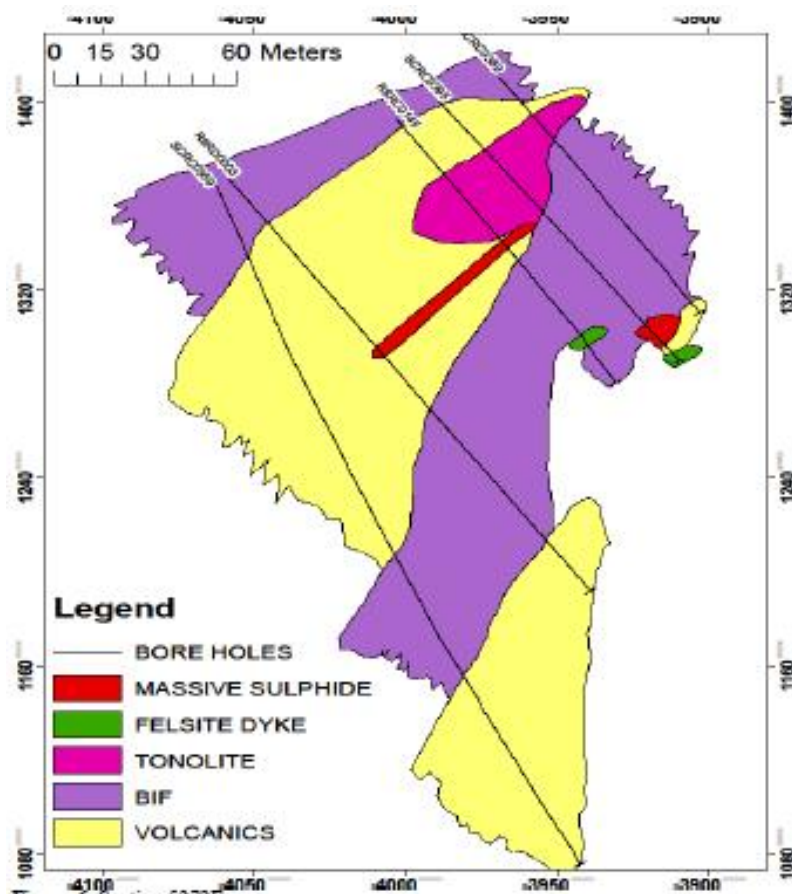
Figure 3: Section 5272E

Section contains 5 holes which are SCRD0389, SCRD0395, SCRD0145, SCRD0003 and SCRD0959 where by interpretation was done and survey data was investigated for hole number SCRD0959 that shows up-dip deviation (uplift) because it is the longest hole with much deviation.

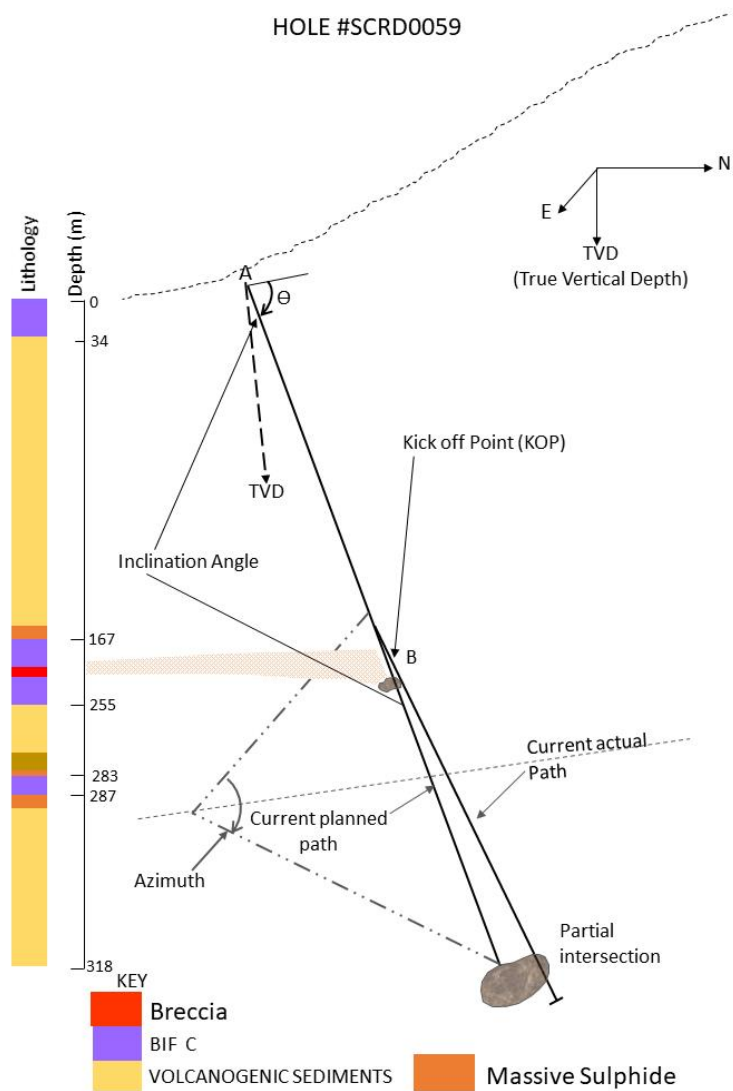
Figure 4: Interpretation of hole SCR0059 with up-dip deviation

This hole was logged and it shows that at the zone of brecciation is where deviation started to develop (see point B below)

The hole was planned with a dip of (71) at zero depth. The drill hole trajectory maintained it's tangential and from the depth of (150.00-190.00) m the big changes started to develop. About 5degrees was lost and the hole started building up at 200.00m is where the Kick - Off Point (KOP) started to generate a significant inclination angle.

The survey data was observed and linked with the lithology of the area of deflection. The deflection was revealed to originate in the zone of brecciation in BIFC. See point B (Figure 4). This might be the cause of the hole deviation (drill hole uplifting). Due to this observation the chances of partial intersection of the ore body might have been encountered.

In Bore hole number SCRD0059 of section 5272E, the deflection was revealed to originate in the zone of brecciation in BIFC. In Bore hole SCRD0027 of section 5010E, the contact between two lithologies which were from soft to hard with unchanged drilling force is the one thought to be reason of hole deviation. In Bore hole number SCRD0392 of section 5250E, the presence of folds was thought to be one of the reasons for hole deviation.

Based on the results of this study it is recommended that the effects of the formation and profile observed could be controlled easily by controlled drilling with low penetration rate /rotation in the weathered profile, when drilling a weak zone with geological structures like folds, fault and shear zones. Also, when drilling near contact between lithologies the penetration rate should be lowered so as to avoid shifting of the drill bit and missing the target. The down hole survey need to be done in a small interval so as to adjust the measurements before hole deviated gets so far.

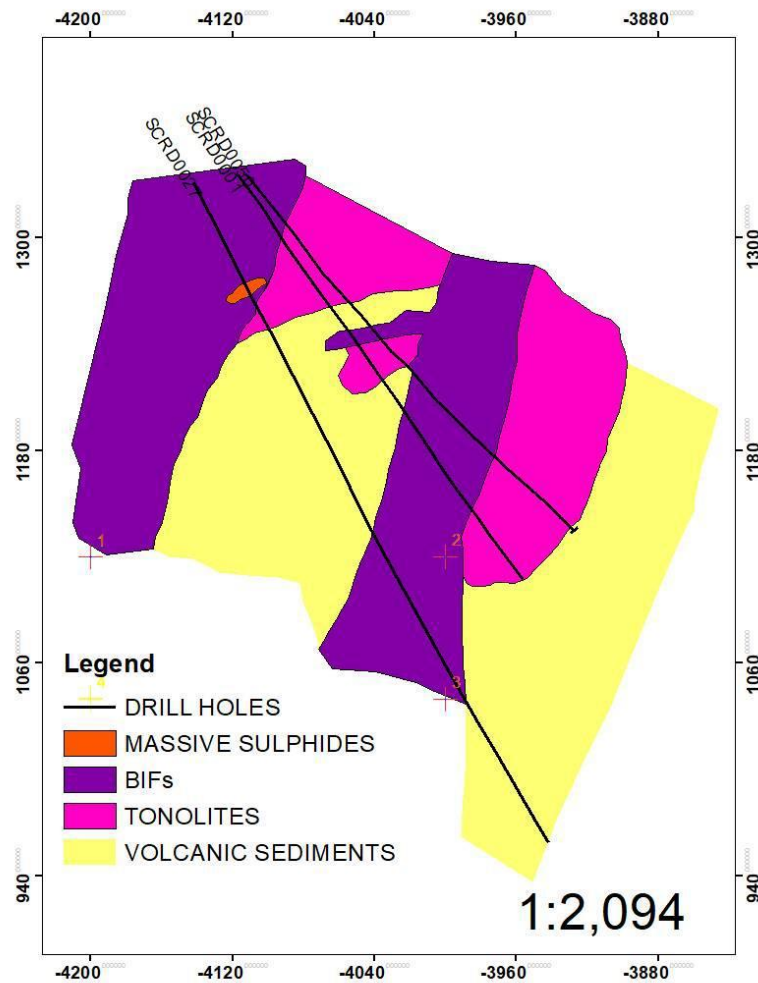
Figure 6: Section 5010E

A section 5010E with the longest hole SCR0027 in which interpretation was made and turning (Lifting) of the drill hole SCR0027 was observed.

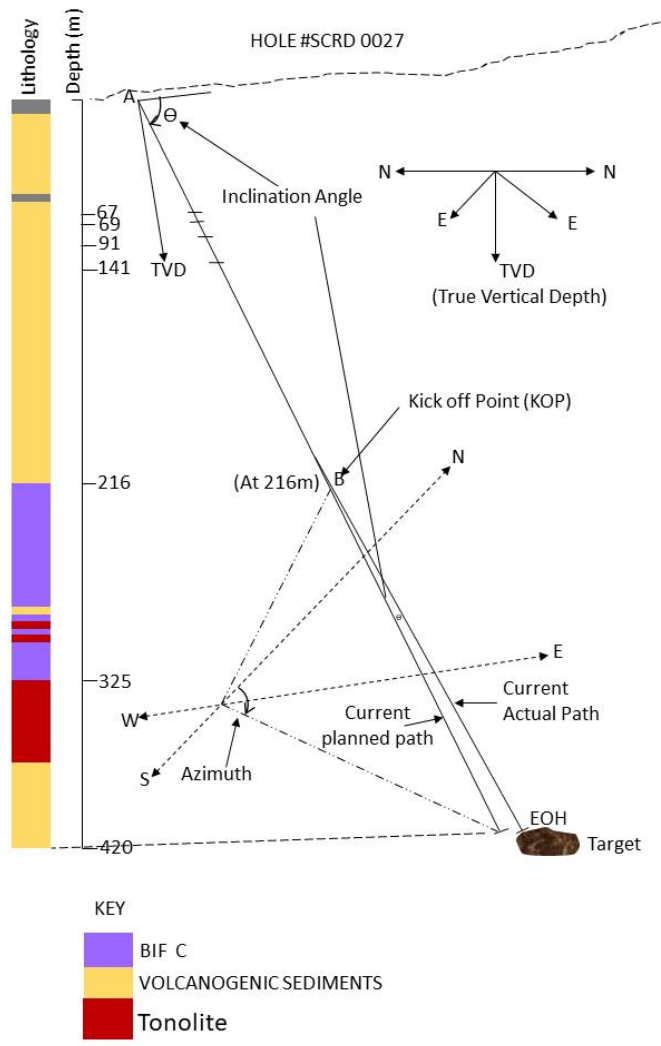
Figure 7: Interpretation of hole SCR0027 with up-dip deviation

The hole was planned with a dip of (65) at zero depth. The drill hole trajectory maintained its tangential and at the depth of (216.00) m the changes of degrees began from (62-61degrees) and the hole started to building up.

The kick off point start to be generated at the contacts of two lithologies where the hole started lifting up. The transformation from soft to hard lithology with unchanged penetration rate of about less than 2000rpm might be the reason of deviation. The contact between two lithologies which were from soft to hard with unchanged drilling force is the one thought to be reason of hole deviation. (Figure 7).

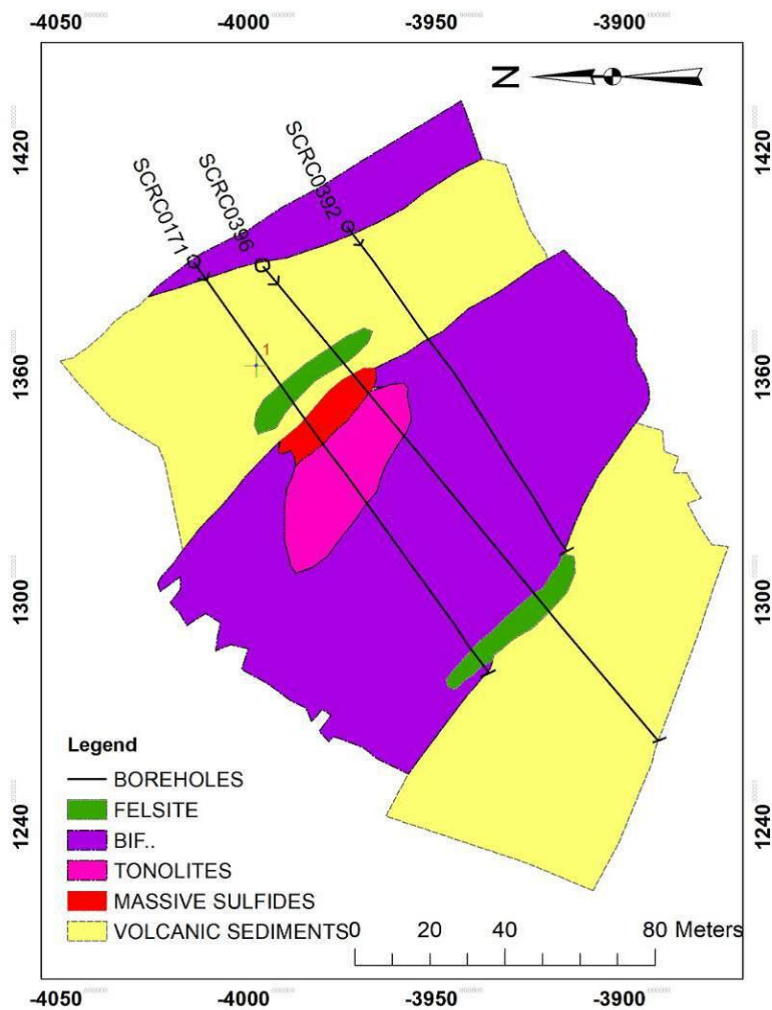
Figure 8: section 5250E

A section 5250E with dropping deviation of hole SCRC0392

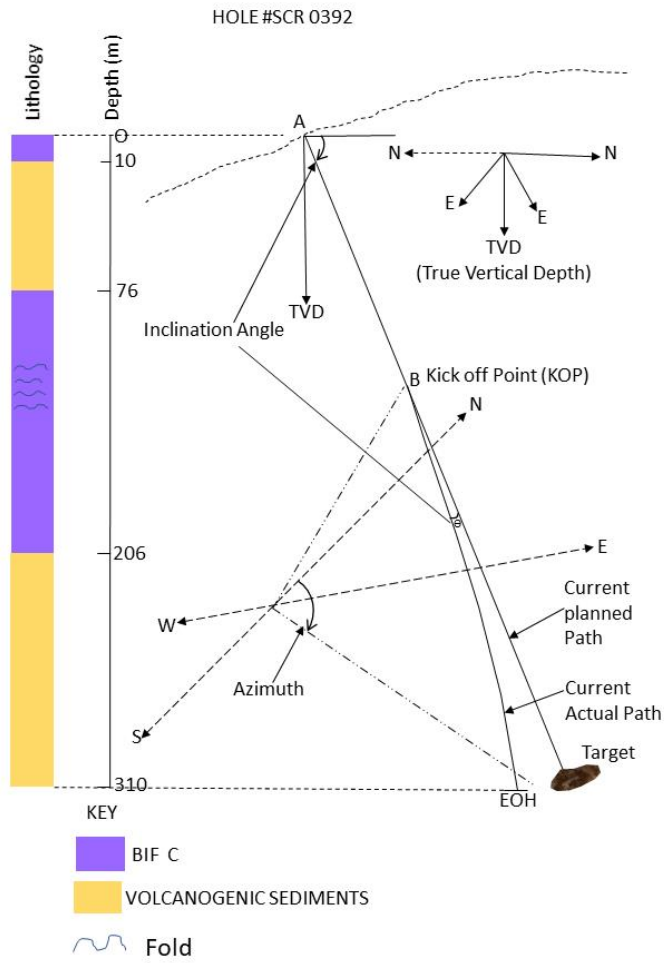
Figure 9: Interpretation hole SCRC0392 with down-dip deviation

Data from this drill hole indicate a possible upper and lower saprolites in the weathered profile and BIFC, TUFFs then a massive sulphide zones.

The drilled holes show dropping effect from planned path. The drill hole is straight until the KOP where it is kicked off and an angle is built at folded zone (Fig 13) due to ground condition. The presence of folds was thought to be one of the reasons for hole deviation. When the deviation starts the inclination angle is reached, the drill hole path is kept tangent or curved away from the desired target, hence the target is missed. (Figure 9)
